SC Status

22nd International Workshop
on DEPFET Detectors and Applications

09.04.2018

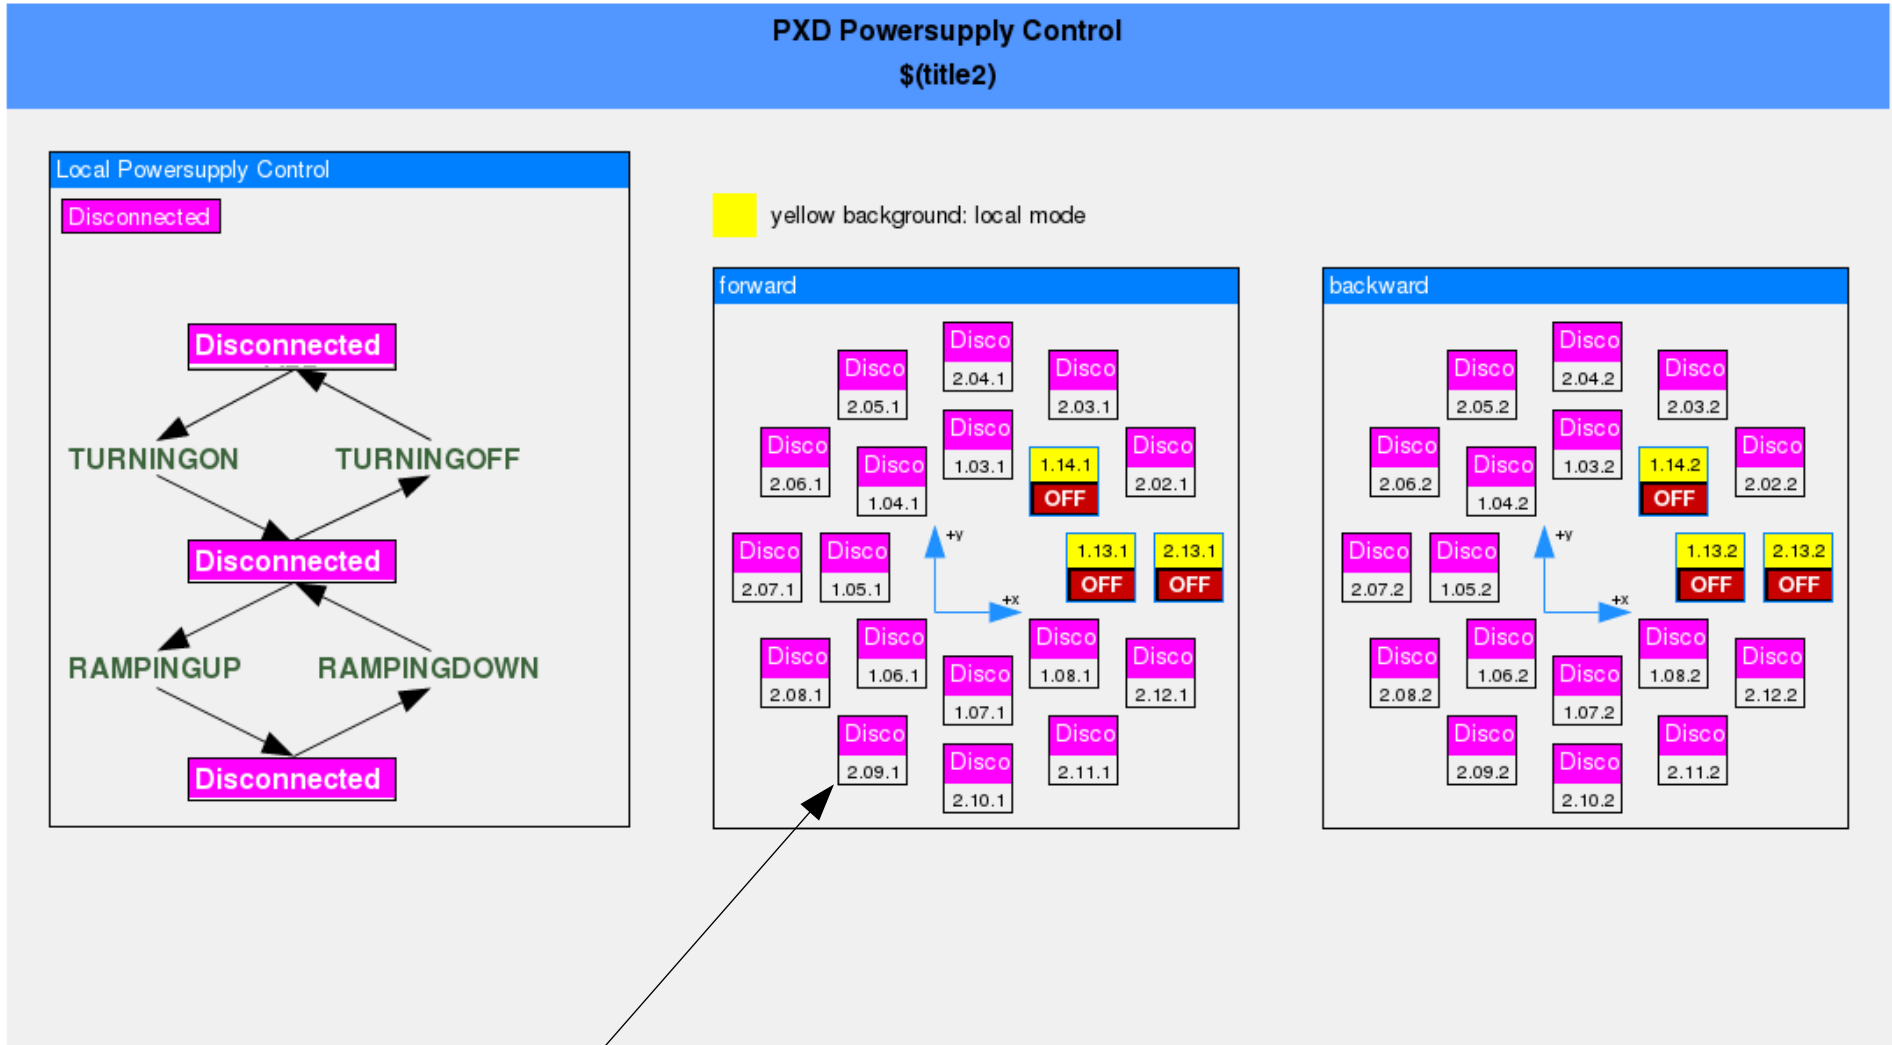
PXD PSC GUI

left-click: descend.
right-click: go local, emergency shutdown.

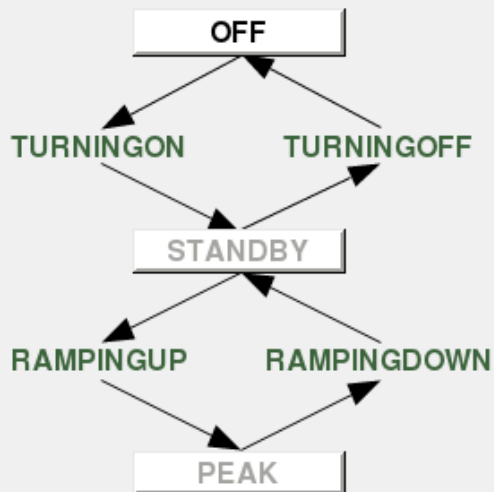
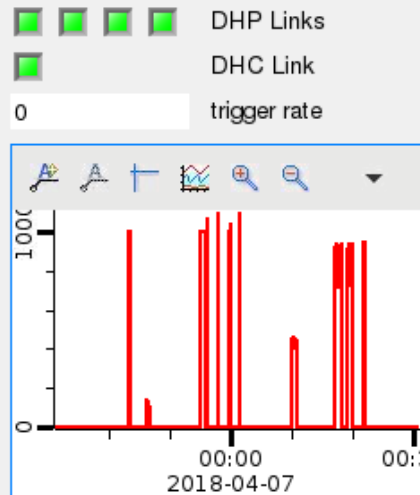
Single Module GUI

PXD Module 1131

Local Powersupply Control

Global Run Unit is disabled.

Power Chain

- module powered
 - PS interlock
 - PS OVP
 - PS connected
 - PS powered 0.85 A
 - power
 - primary power
-
-
-

Data Path
