ONSEN Status in Phase 3

PXD Workshop and 23rd International Workshop
on DEPFET Detectors and Applications,
May 2019

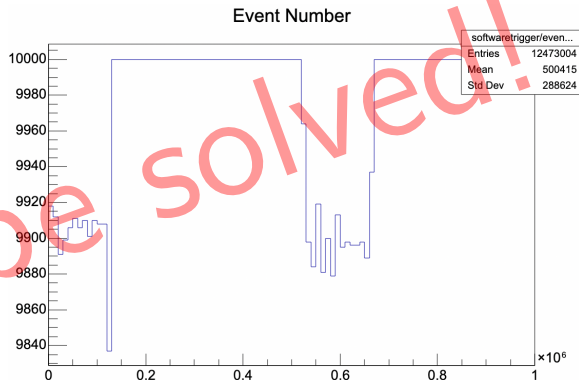
Missing HLT events at run start

- Missing events from HLT
 - ▶ some processes on worked nodes die
 - ▶ PXD data lost in ONSSEN memory
- Mainly happens at run start
 - ▶ 1000 events
- Check in ONSSEN is currently disabled, to prevent run stop after 4.2 M events
- Not problematic at current occupancy of 0.05%

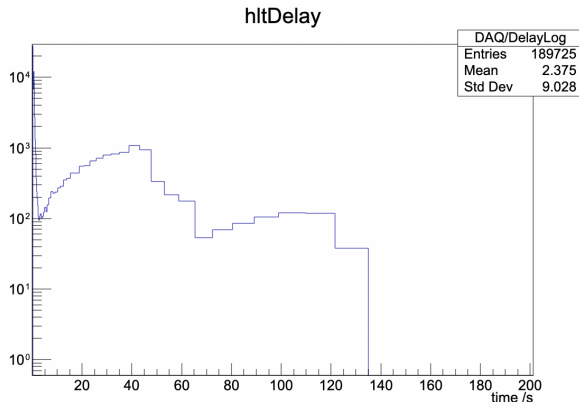
HLT processing time

- ONSEN memory designed for $< 5s$ processing time
- Not problematic at current occupancy at $\sim 0.05\%$ and trigger rate at $< 5\text{ kHz}$
- Situation will improve with load balancing
- Partly due to the initialization of basf2 ($\sim 30s$)
 - ▶ might improve in future by moving initialization to LOADING stage
