PXD2 DETECTOR PRODUCTION UPDATE

PXD2 PREPARATION

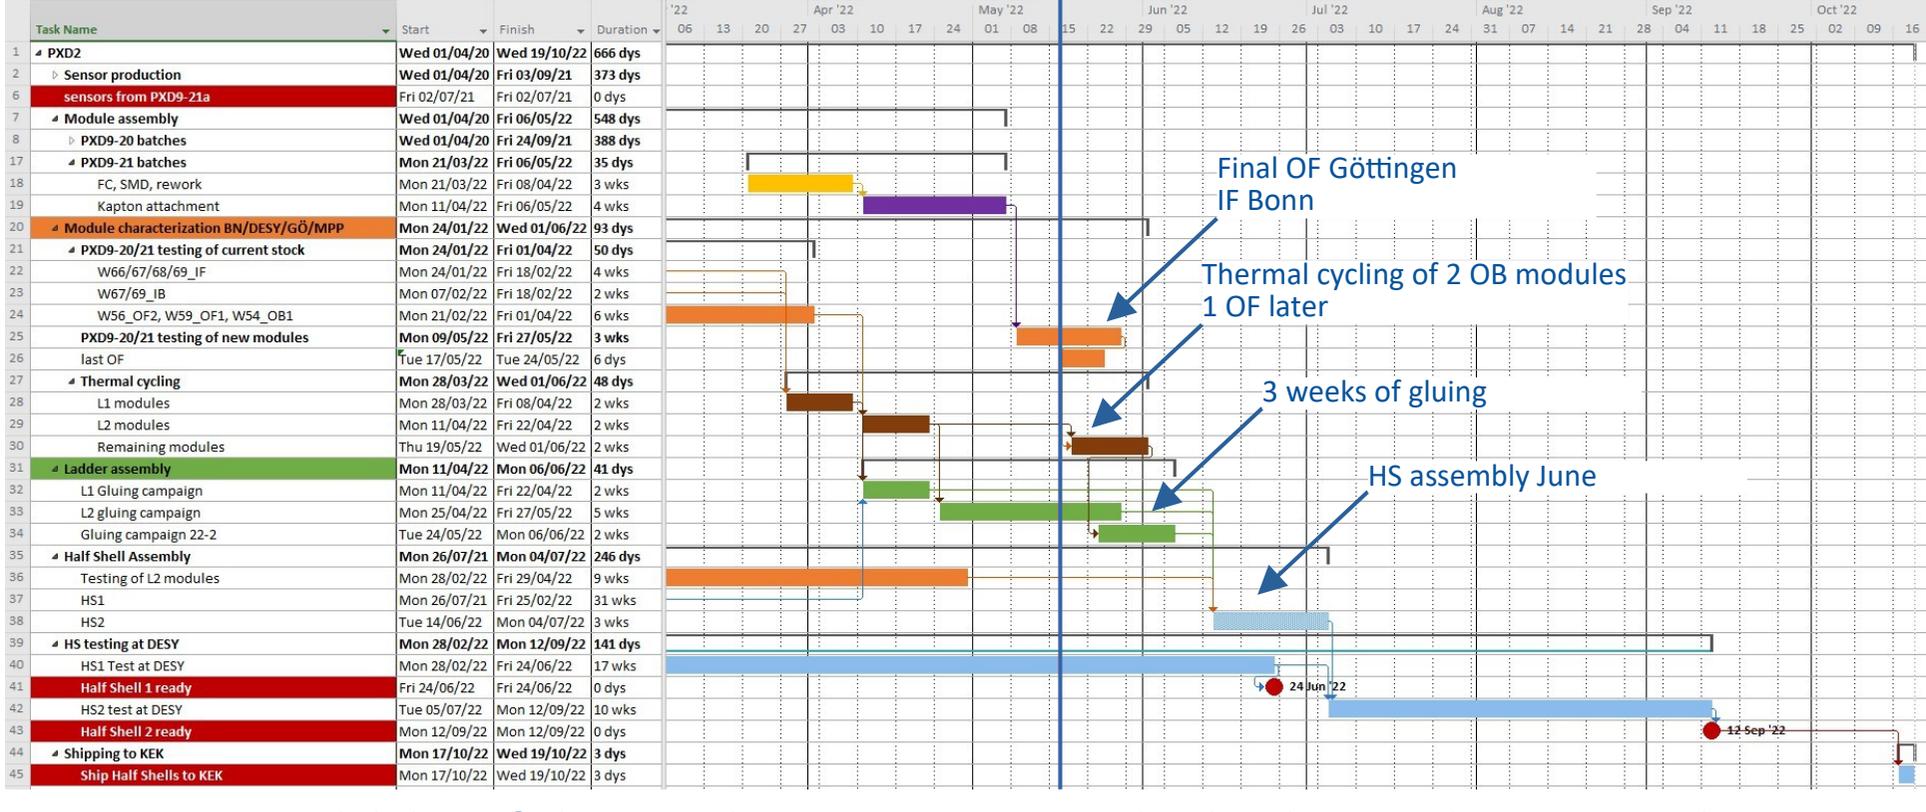
PXD2 PRODUCTION SCHEDULE

Availability of gluing and mounting experts absolutely crucial May + June!
