# DHH Status

**Igor Konorov**

PXD and DEPFET Workshop 22-24.05.2023

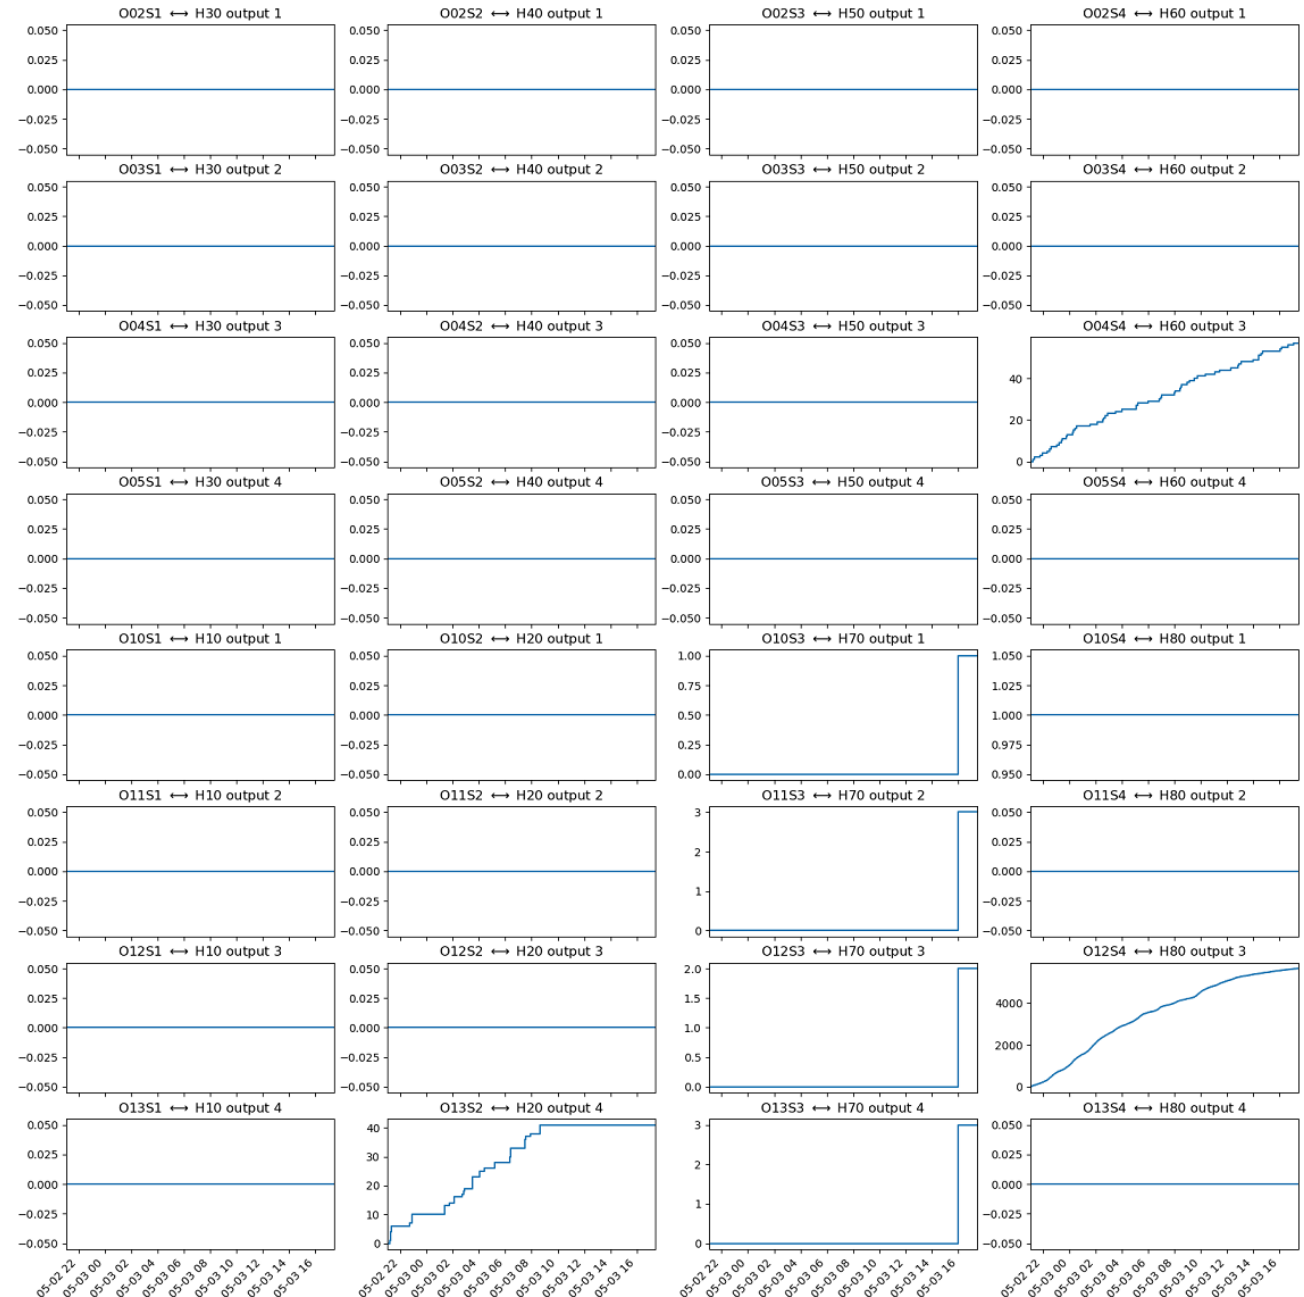
## Origin of the problem and solution

- Not fully plugged connector between CC  $\leftrightarrow$  RTM
- Small displacement of connector in the design

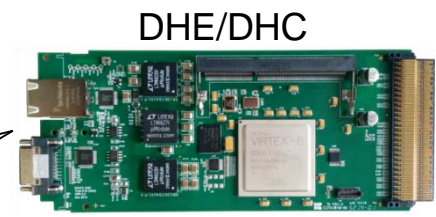
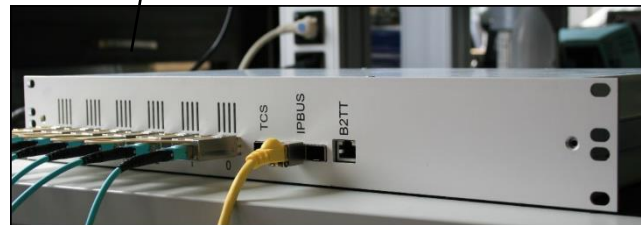
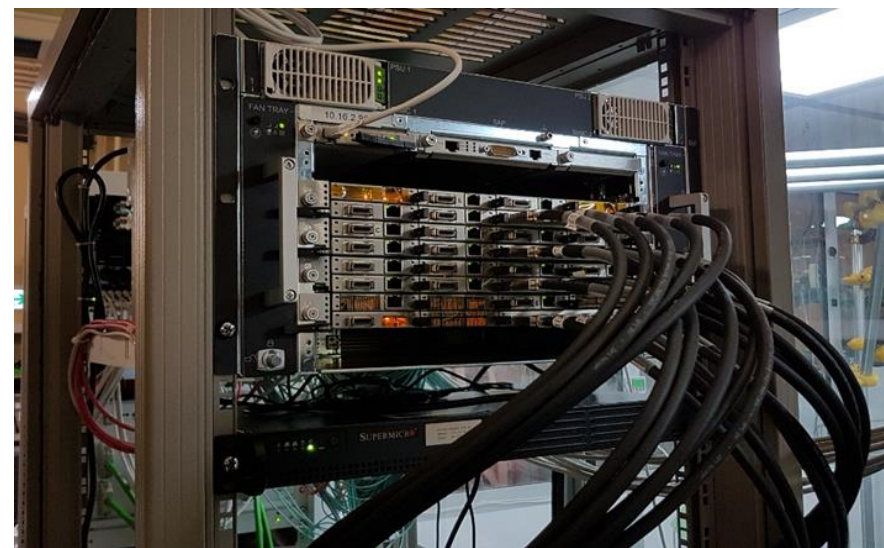
# PXD Readout Overview

- Cross-point switch : 144x144 @6GB/s
- DHHCC : ATCA
- DHI : A7XC100T, Configuration and Trigger
- DHE/DHC : V6XC130 FPGA, 4GB memory, Data processing
- DHH : DHI + 5xDHE + DHC
