Contents:

- Design of Service Area (Pipes & Cables)
- Dock Ring and Cable Cages
- Dock Boxes
- PXD Support Jig
- BEAST 2 Preparation

C. Kiesling, 20th International Workshop on DEPFET Detectors and Applications, May 11-14, 2016, Kloster Seeon

Cable / Pipe Layout in VXD Area

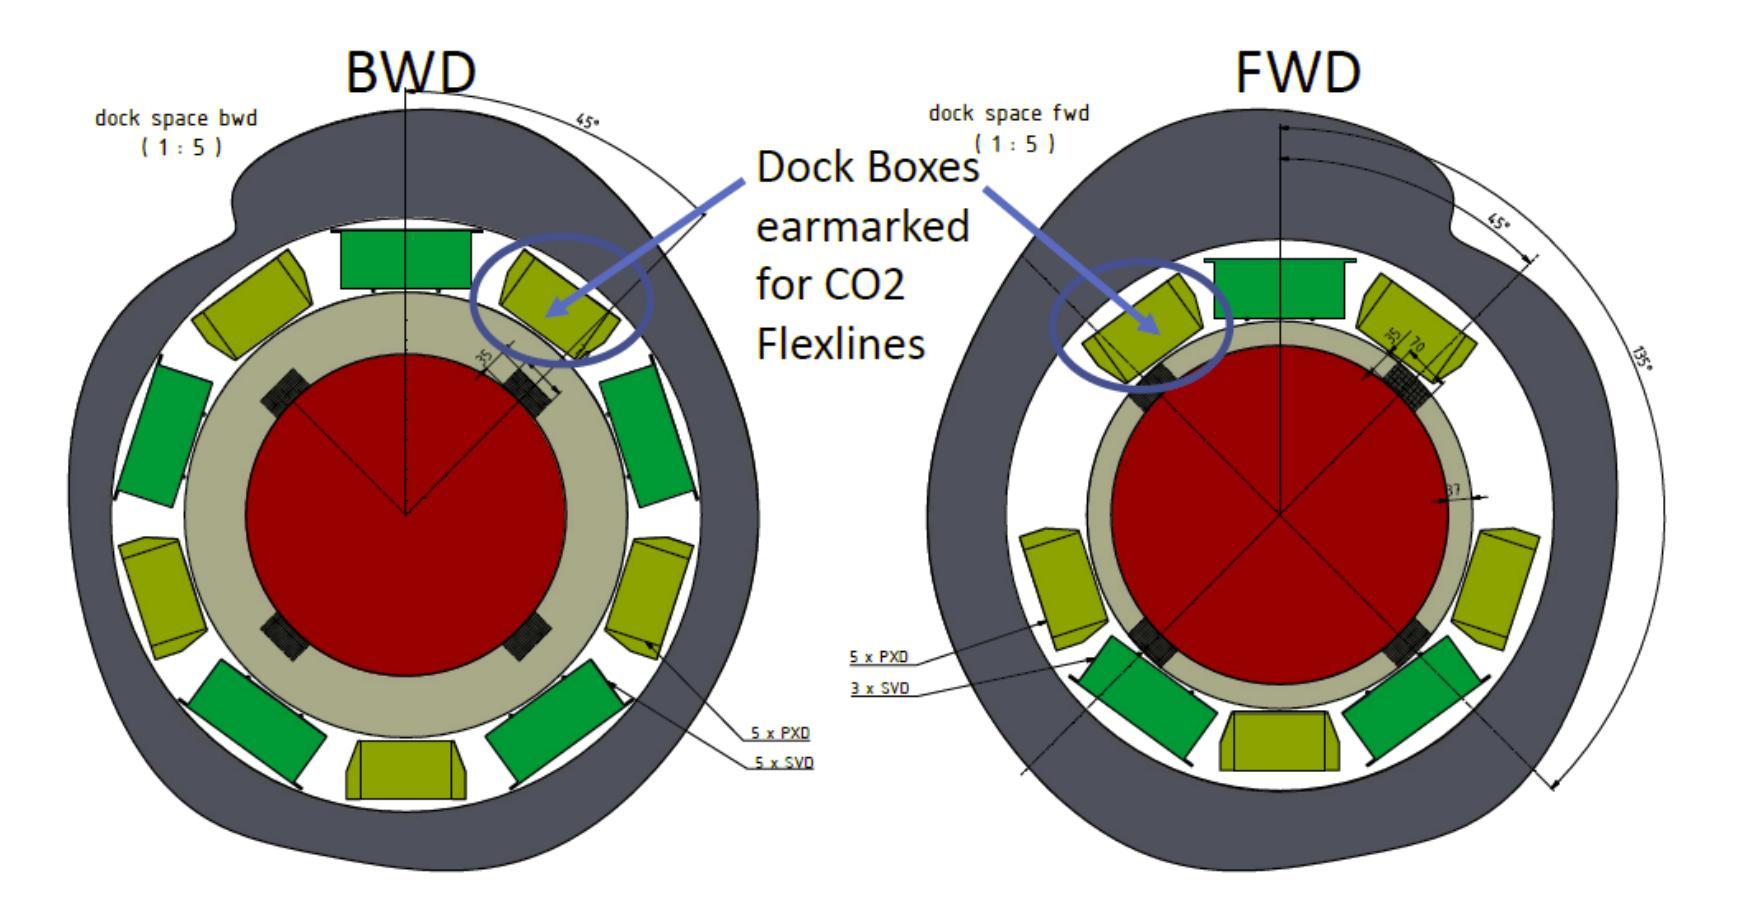
General rule: all services must have a connection at the docks

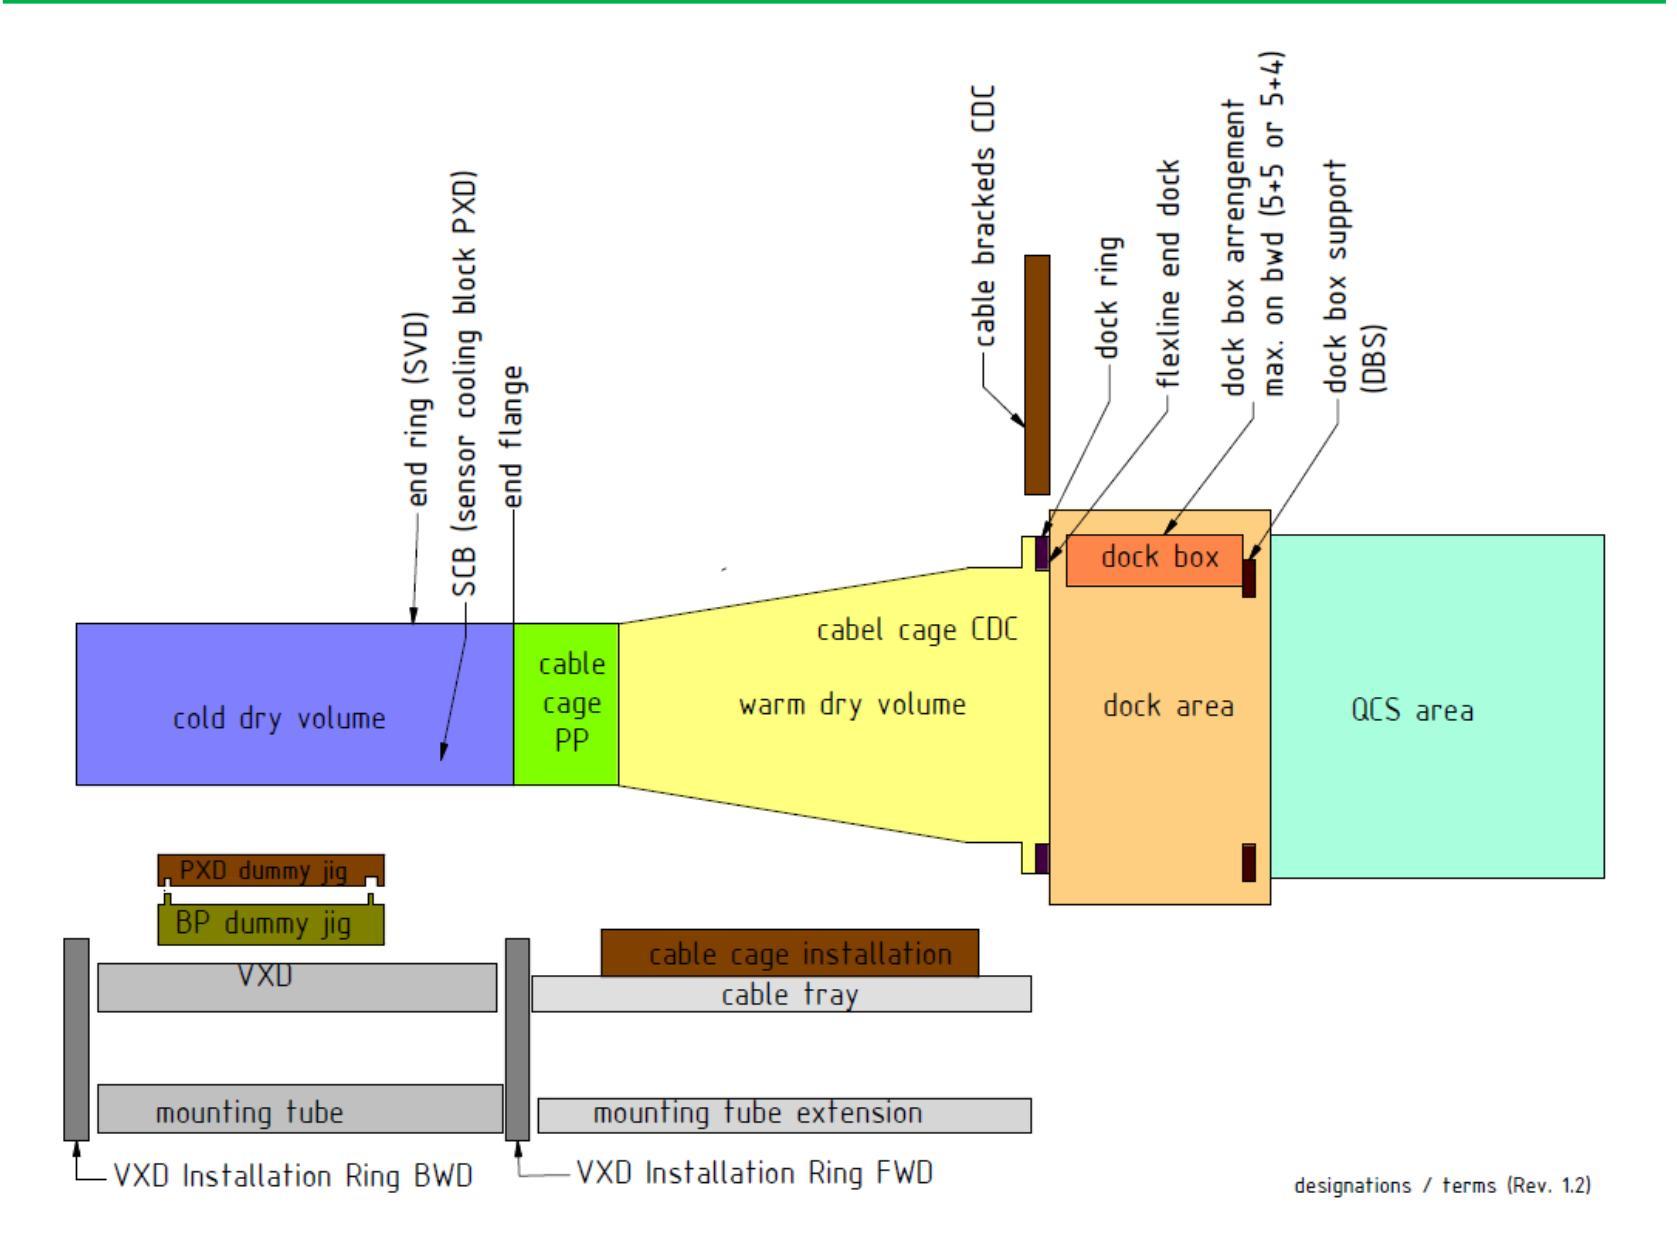
Signal/Power lines now compressed into 4 dock boxes Optical signal standard chosen because of mechanical reasons

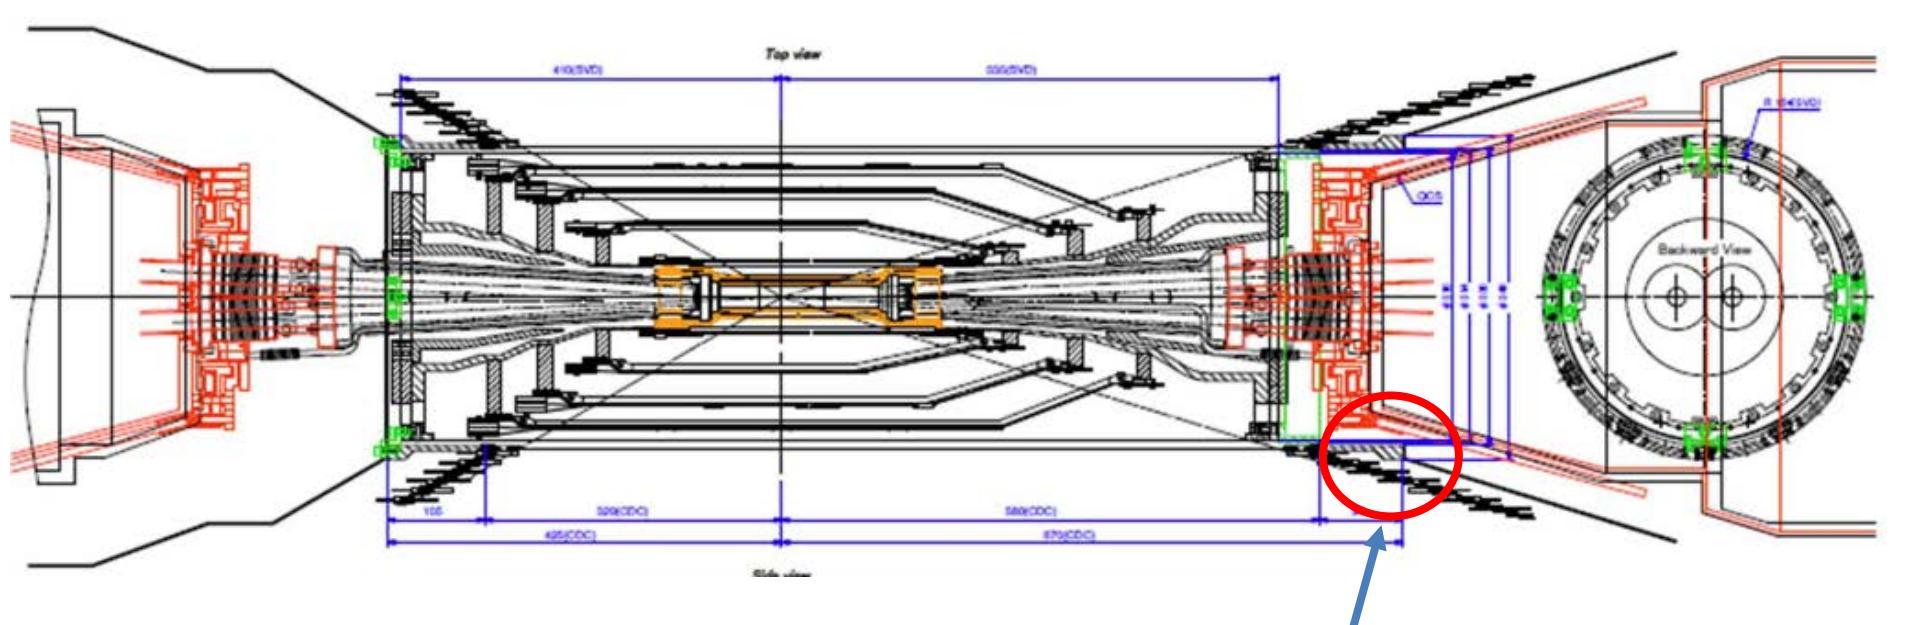
Extremely narrow gap in the FWD regions between inher CDC wall and QCS: only 24 mm clearance.

This must be sufficient for the 267 cables and pipes AND has to conserve the "7 mm" rule: gap between cables and QCS outer envelopec

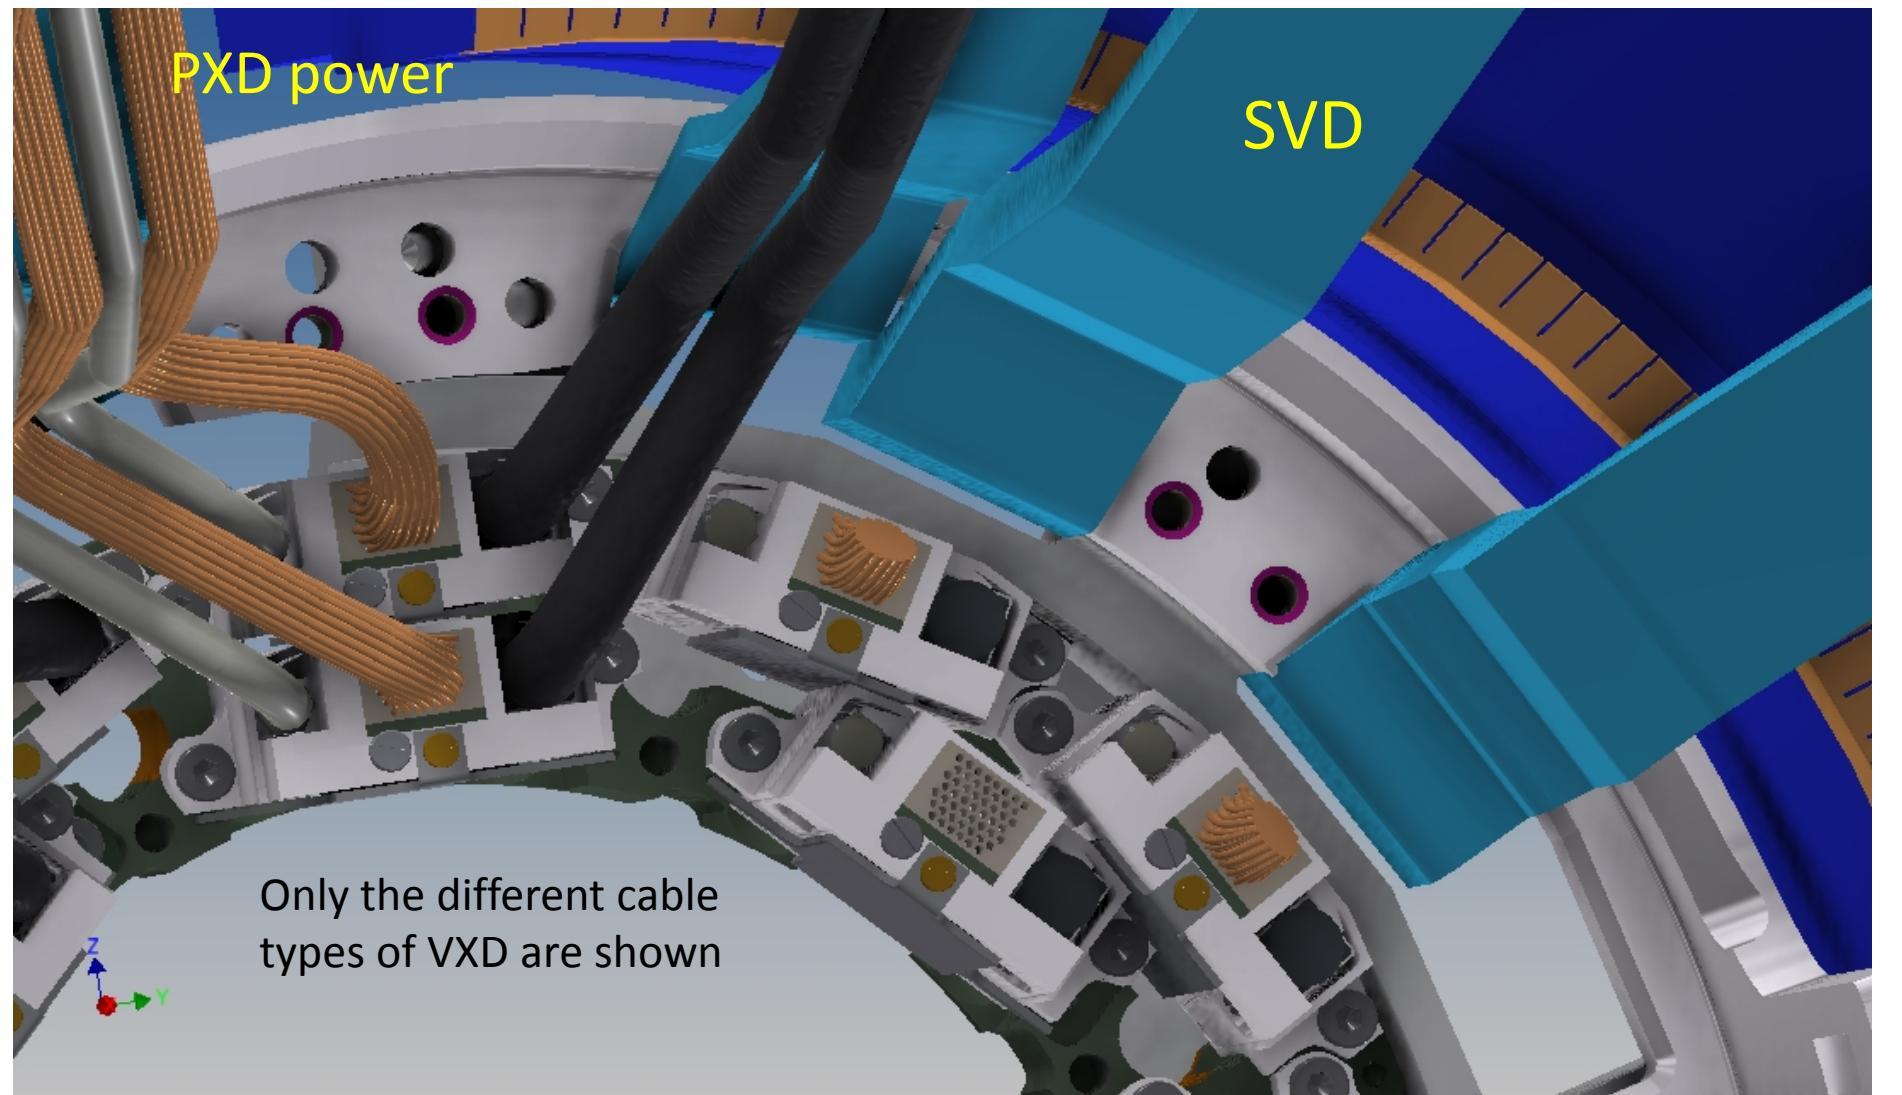
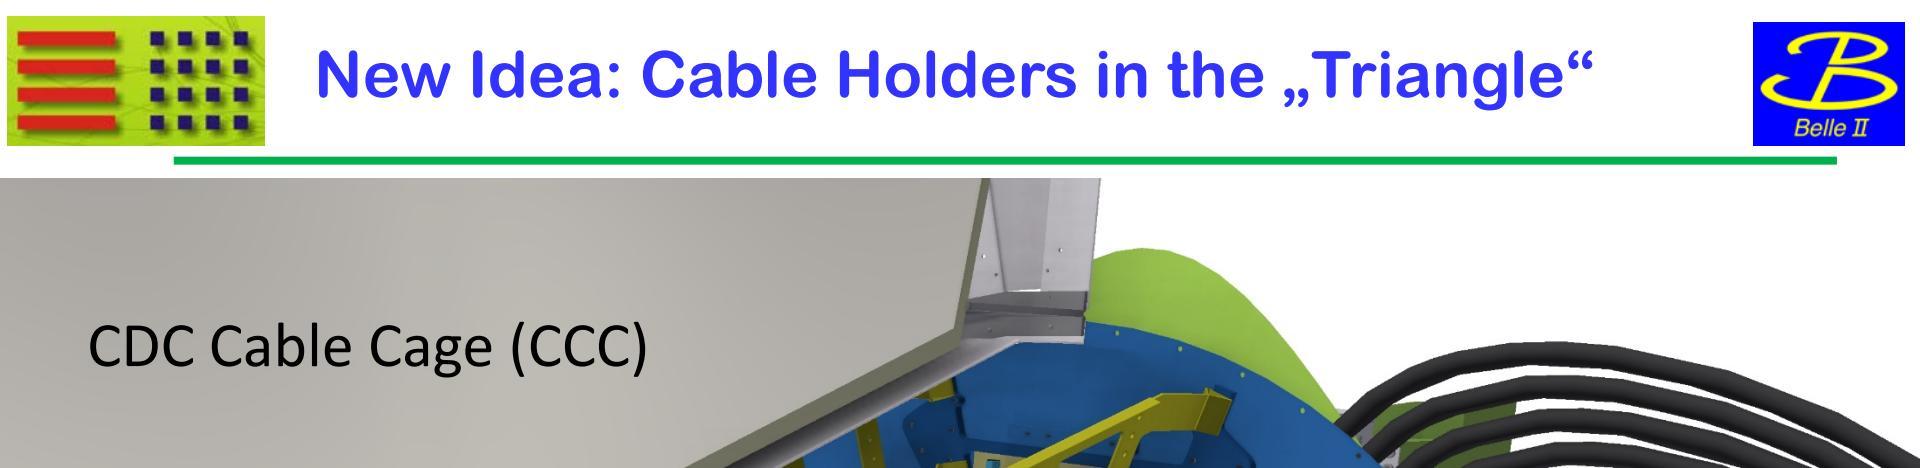
Crowded Region at VXD End Flange

PXD ctrl

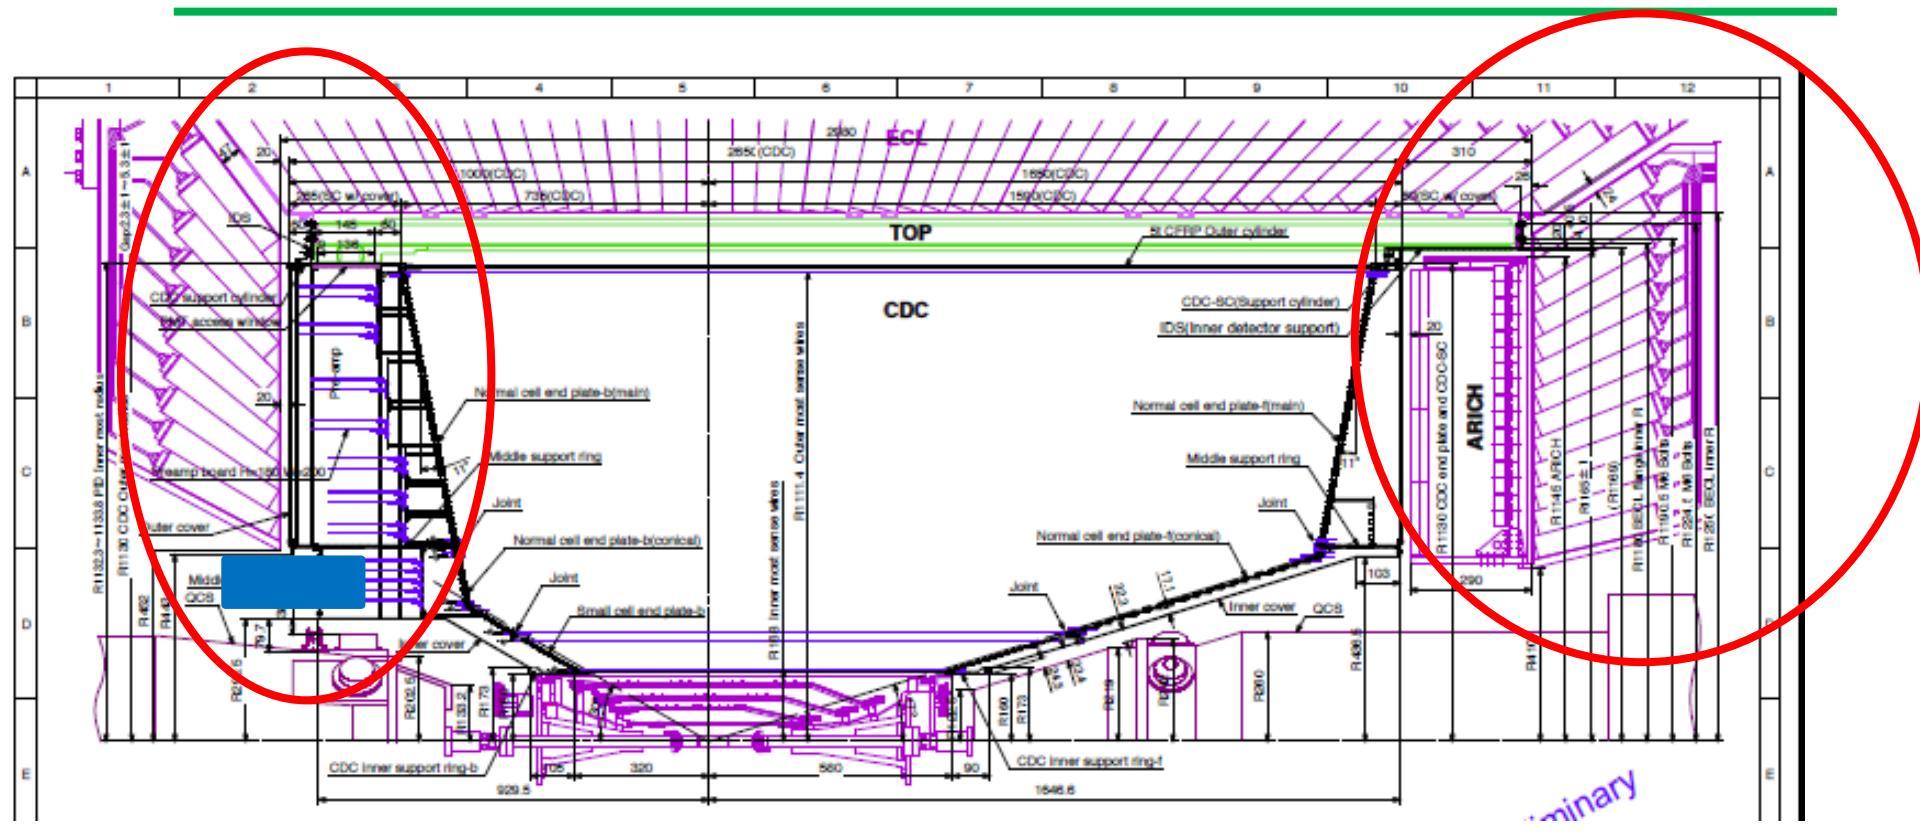
Going out to the Belle Platform

Problematic: Dock Box area in the BWD region (for SWD) CDC wall in the BWD region Chicane in FWD

Discuss cable routing again with Adachi-san
