Neutron Irradiations and Punch-Through-Biasing Studies with DEPFETs for BELLE II

13th International Workshop on DEPFET Detectors and Applications
Ringberg, 13th June 2013

Stefan Petrovics

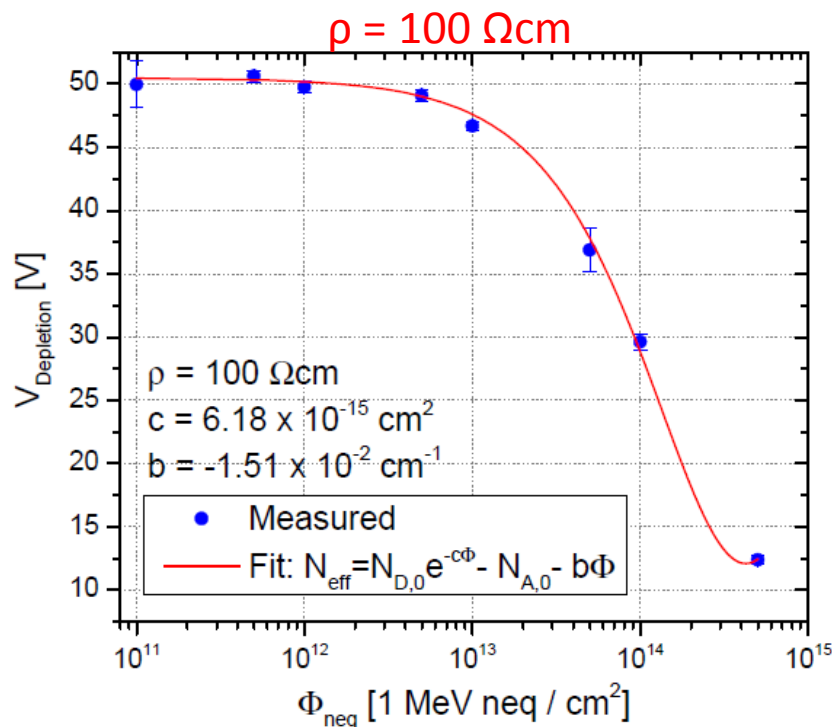
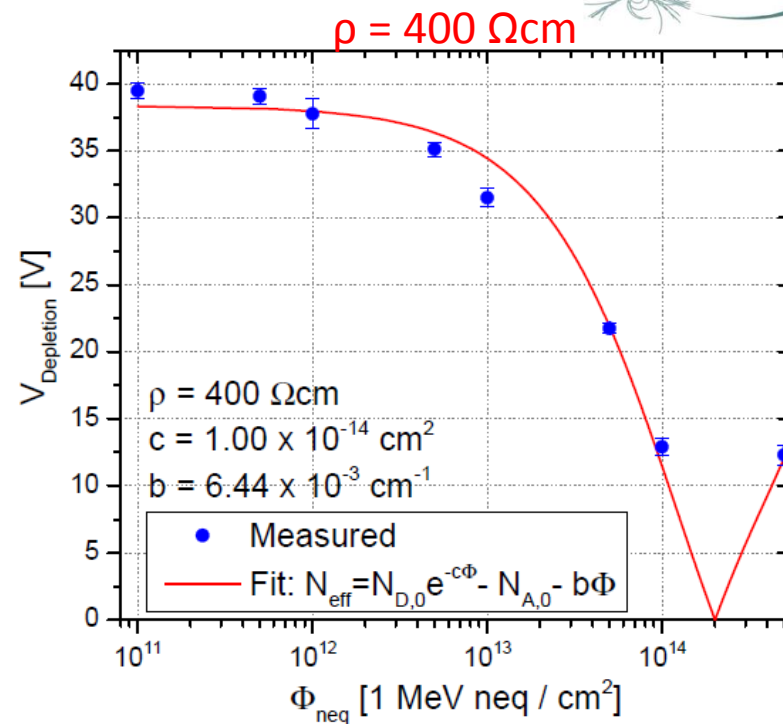
Change in full depletion voltage

Measurement of full depletion voltage of diodes after different neutron fluences:

- initial decrease of depletion voltage in both cases
- type inversion of 400 Ωcm material at approximately $2 \times 10^{14} \text{ neq/cm}^2$
- increase of depletion voltage after type inversion
- no type inversion in the case of 100 Ωcm material

→ lower resistivity material is more radiation hard in terms of type inversion
→ no type inversion of DEPFET structures after ten years of BELLE II operations
($\phi = 2 \times 10^{13} \text{ neq/cm}^2$)

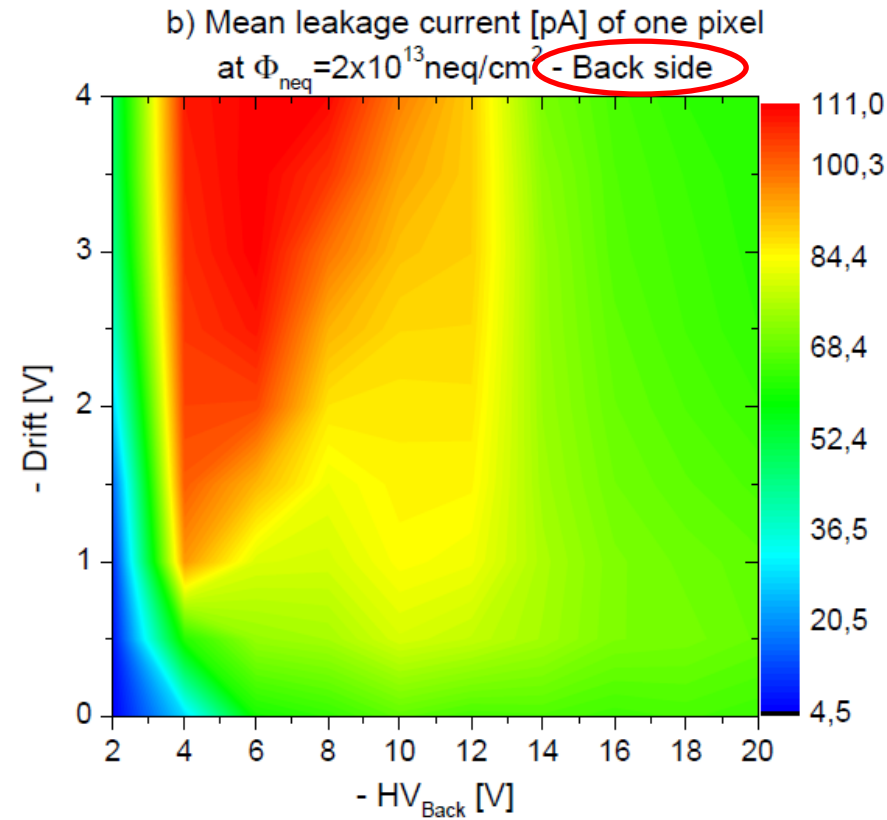
Performance of DEPFET matrices

Measurements of DEPFET matrix behavior after certain neutron fluences showed:

- DEPFET matrices were still functional up to a neutron fluence of $\phi = 1 \times 10^{14} \text{ neq/cm}^2$
- shift of optimal voltage parameters due to decreasing full depletion voltage and threshold voltage shifts of the gate structures

- no type inversion up to $\phi = 1 \times 10^{14} \text{ neq/cm}^2$
- decrease in charge handling capacity of the internal gate due to the threshold voltage shift of the clear gate
- increased leakage currents should pose no threat (**@ 20°C**) for the charge handling capacity of the internal gate, if adjustments to the clear gate and clear low voltages are made

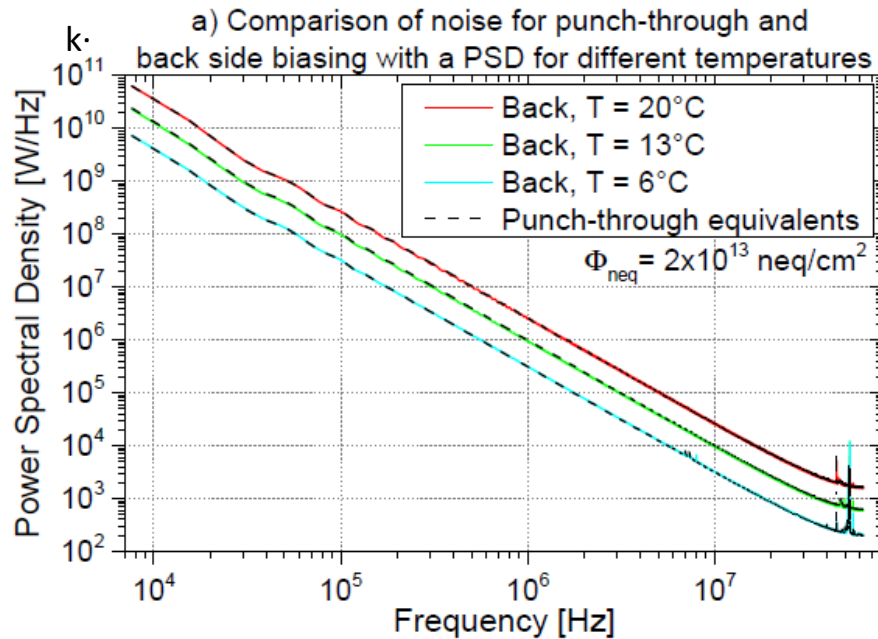
- no additional $1/f$ noise component due to punch-through biasing could be detected in the measurements of all different measurement methods
- no detectable impact of the punch-through noise up to a neutron fluence of $\phi = 1 \times 10^{14} \text{ neq/cm}^2$

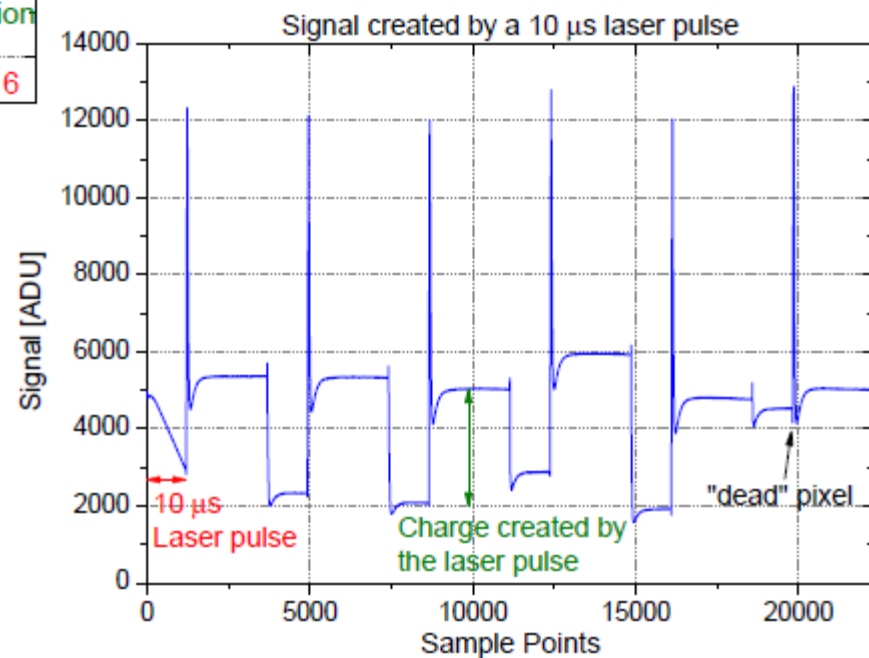
Experimental Setup: MiMa

“Dark measurement”

Measurement with a laser pulse

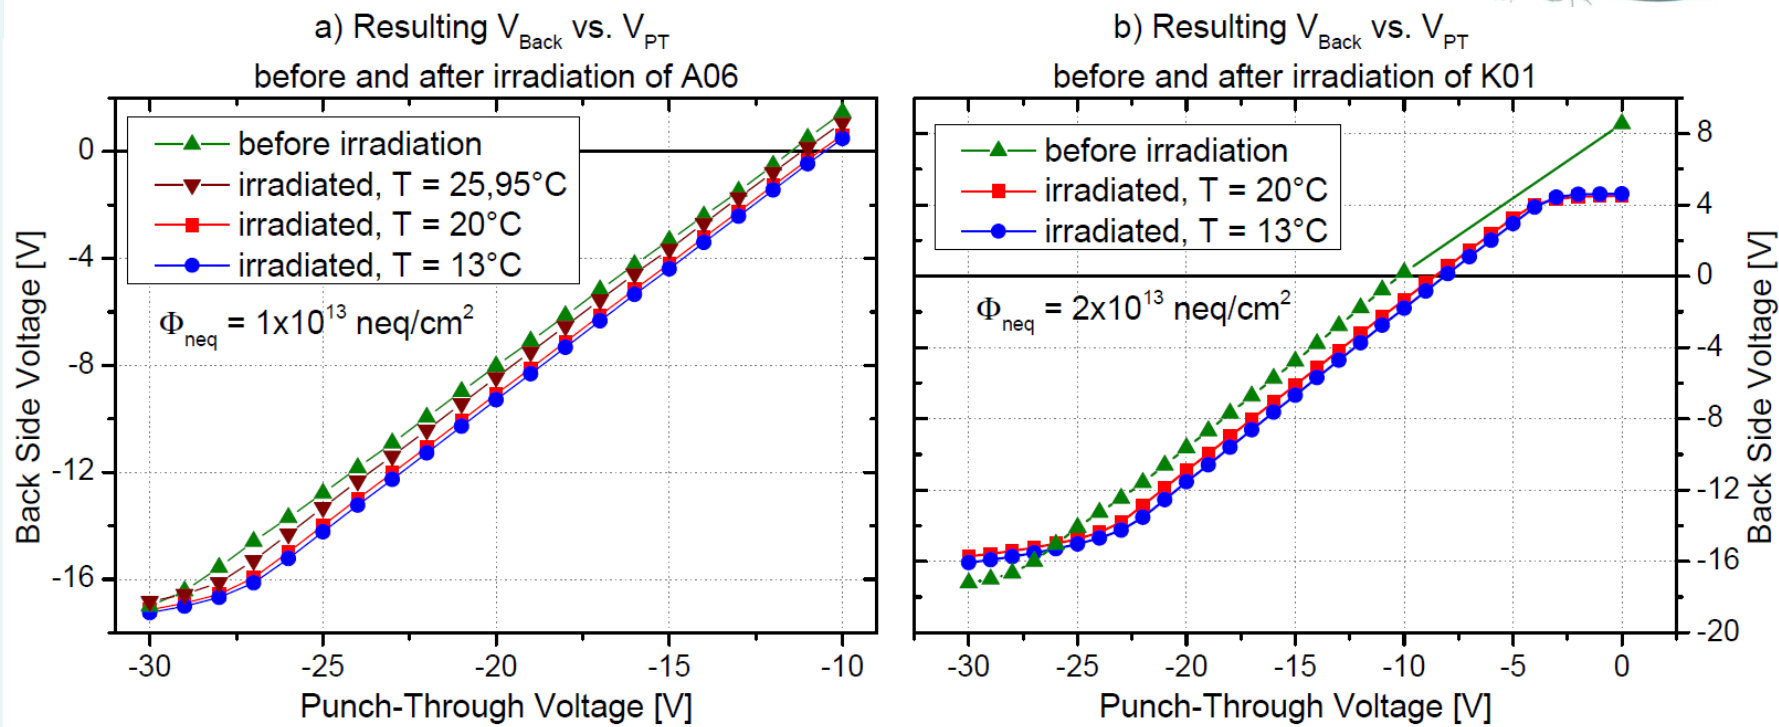
Punch-through biasing

- repetition of the punch-through biasing measurements showed a smaller voltage drop in the detector bulk after irradiation
 - linearity mostly still present
 - decrease in voltage drop to change in effective dopant concentration
- behavior for large bulk currents was unfortunately dominated by the high resistivity bias resistor ($R = 1 \text{ M}\Omega$)
 - increased voltage drop at bias resistor leads to a decreasing effective punch-through voltage

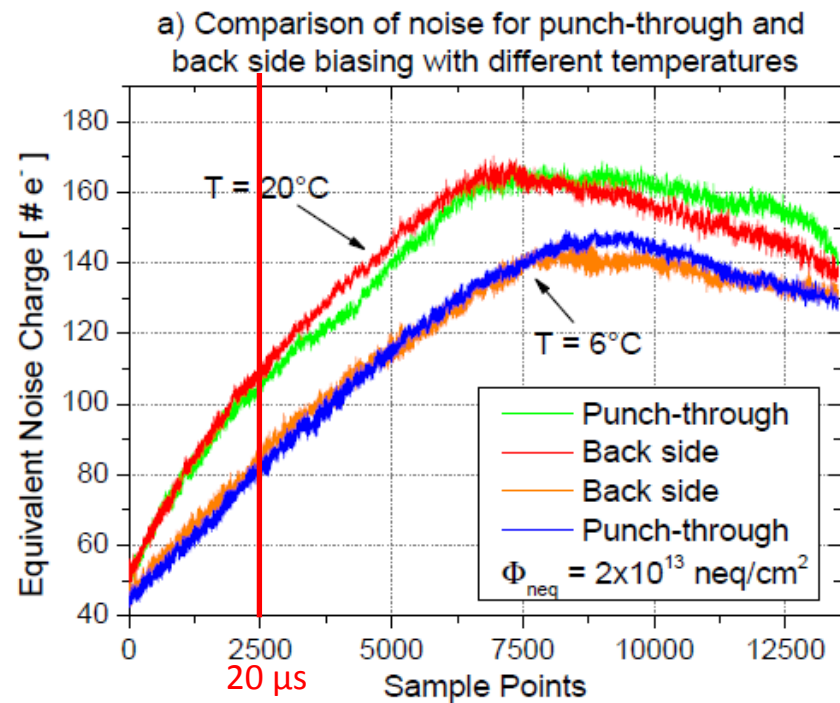
Noise analysis of every time stamp with leakage current
